APPENDIX B – Pre and Post Project Images

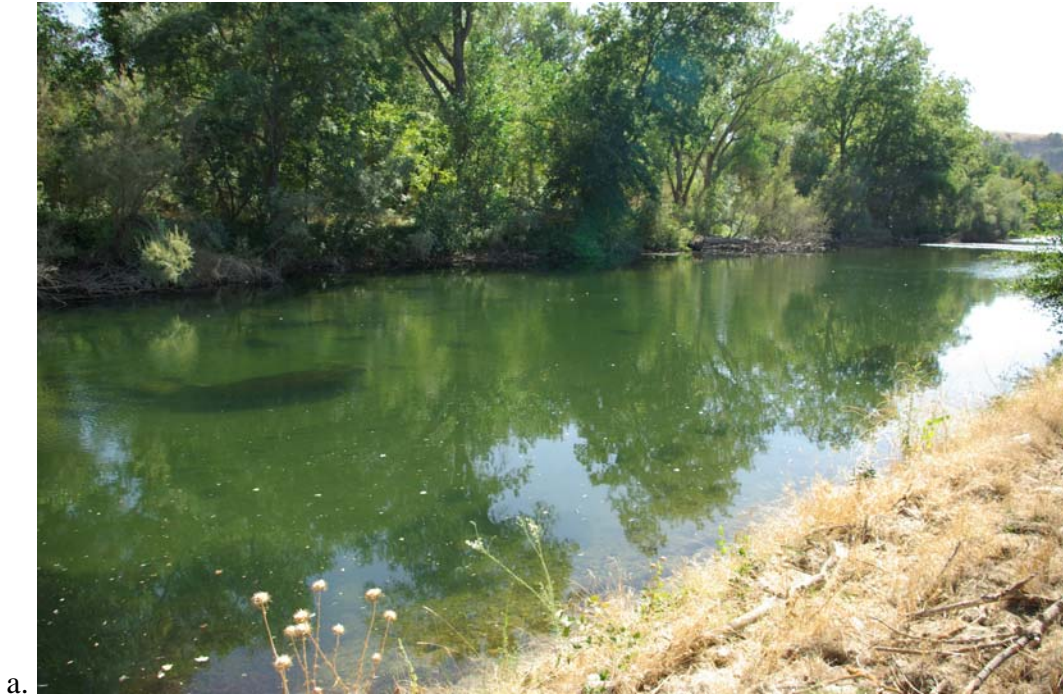
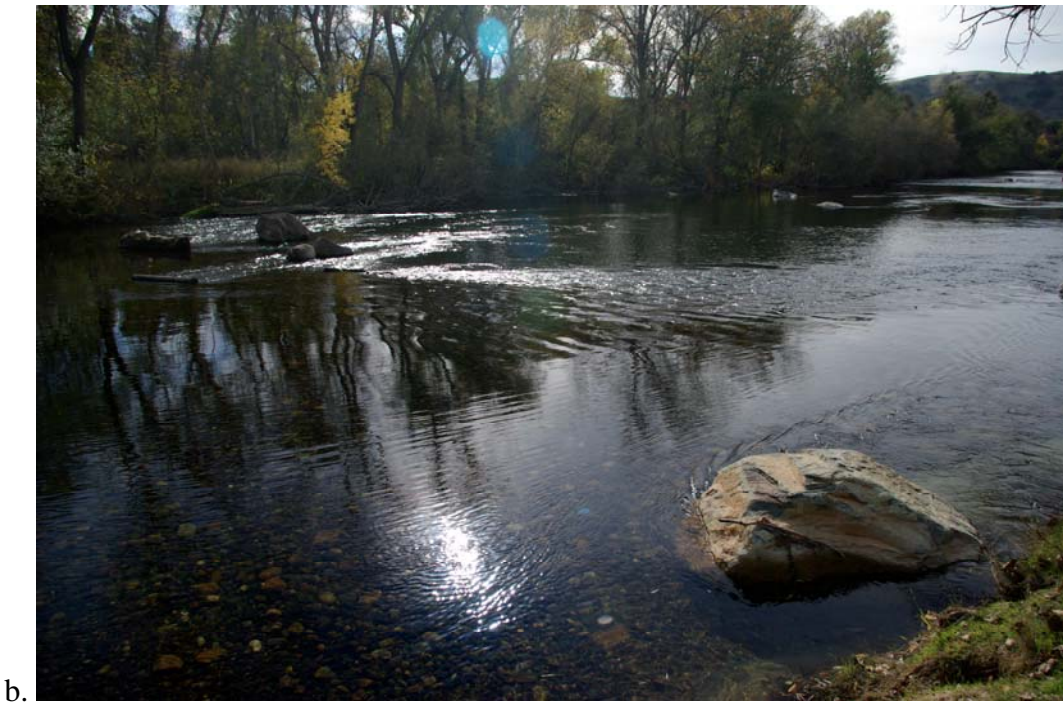
Figure B-1. Riffle 1, Chinook salmon and steelhead spawning habitat suitable for use at flows of 200-500 cfs. Riffle habitat upstream of a roughly 100-foot long pool suitable for adult steelhead holding habitat. (a) Pre-project condition. (b) Post-project condition.

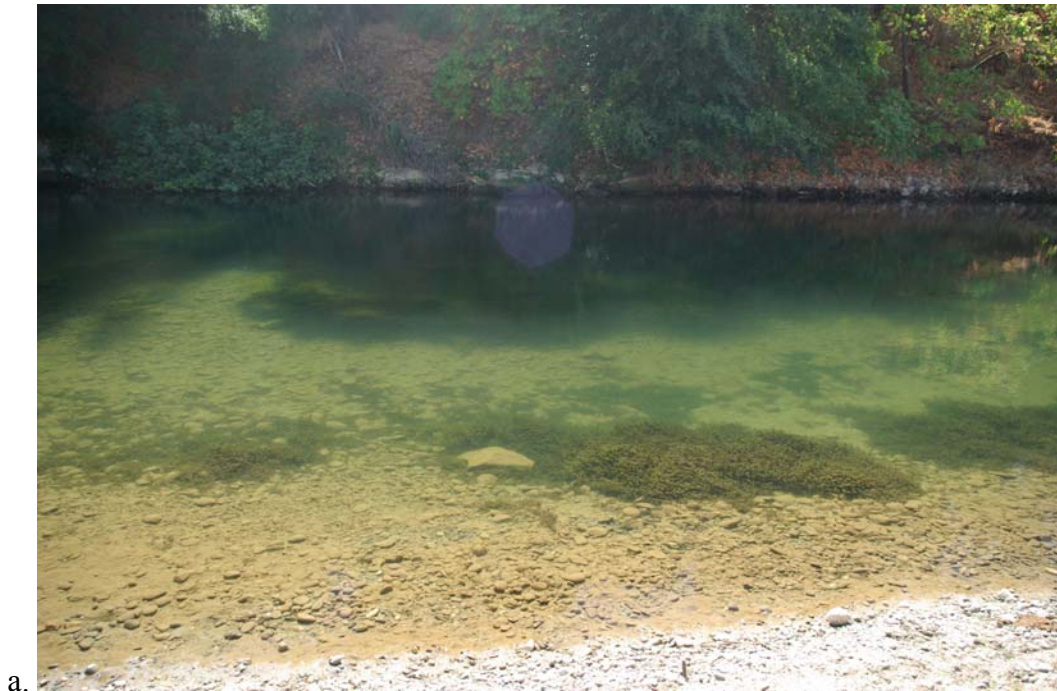
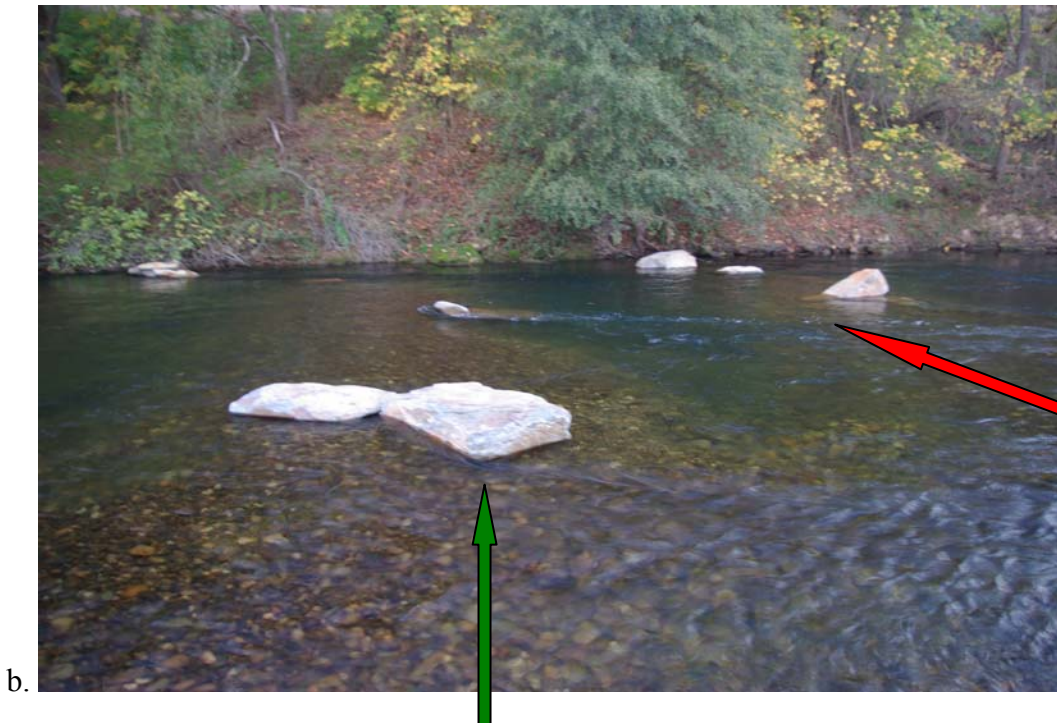
Figure B-2. Riffles 32(green) and 33(red), riffle trough pattern designed for salmon spawning habitat in flows of 200-500 cfs. (a) Pre-project condition. (b) Post-project condition.

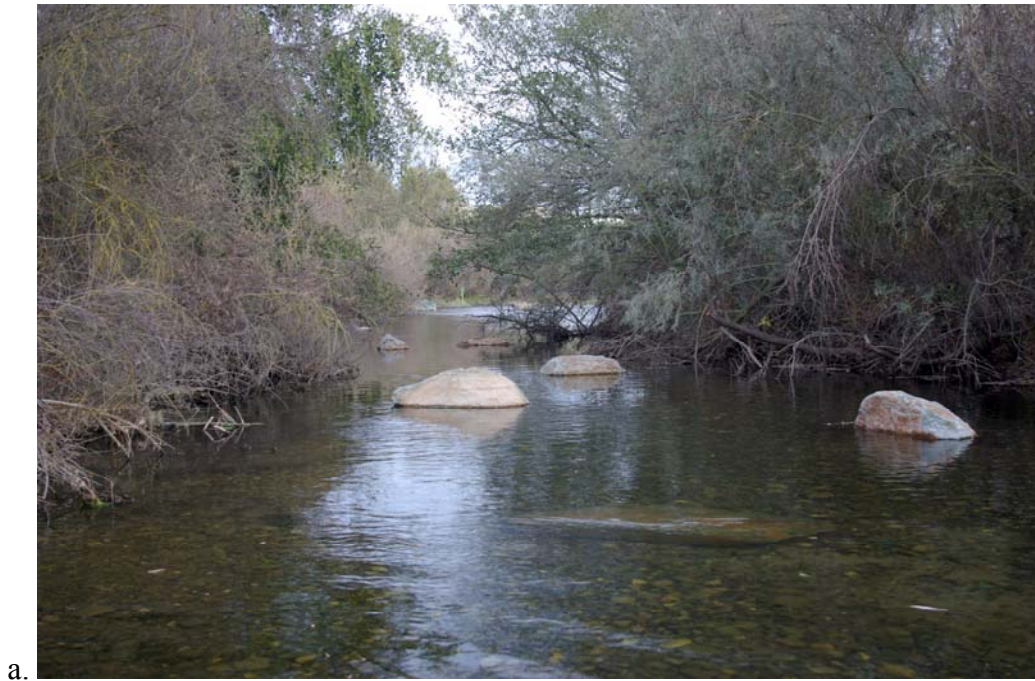
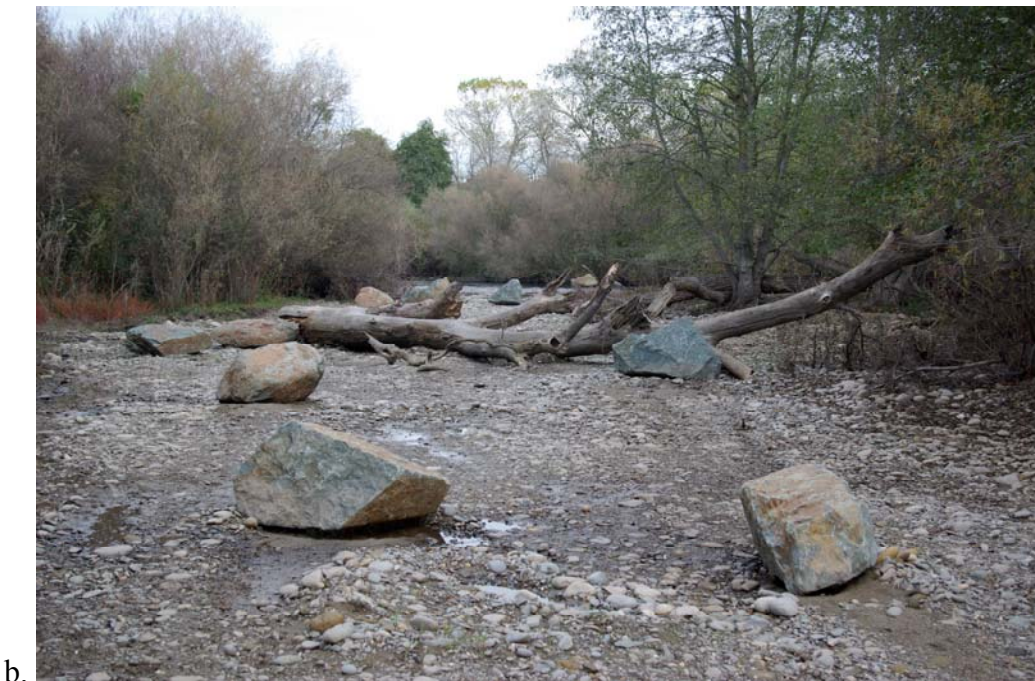
Figure B-3. (a) Side channel 1, post-restoration, functional at flows of 200-500 cfs.
(b) Side channel 2, post-restoration functional at flows ≥ 500 cfs. Side channel 2 spills into a restored floodplain area at flows of 1000 cfs or greater.

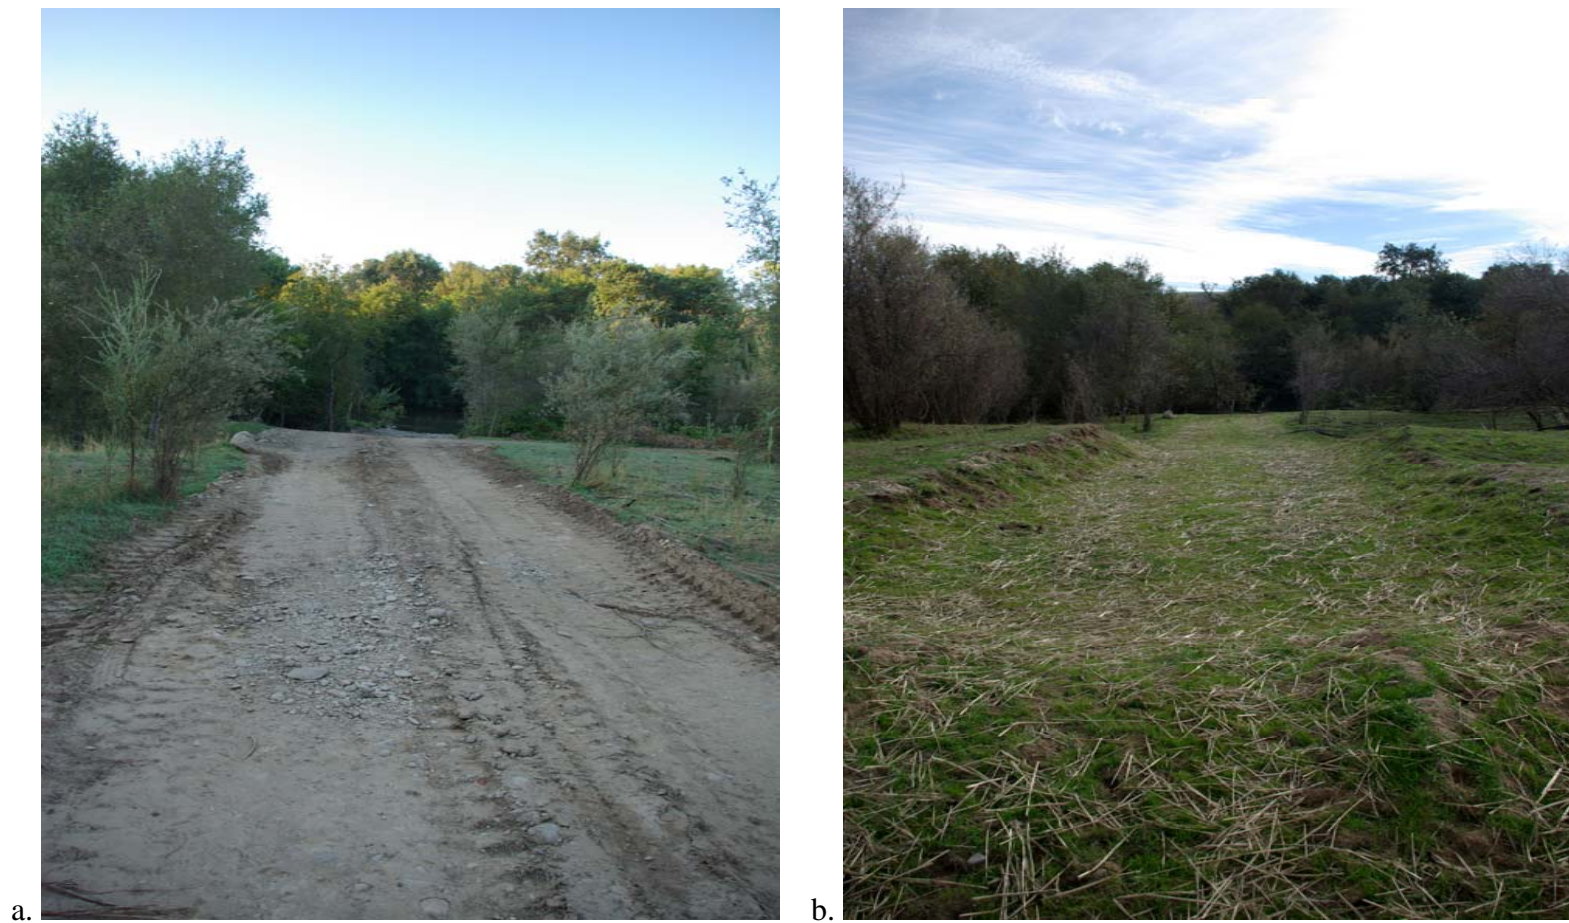
Figure B-4. River access roads pre (a) and post (b) erosion control measures.

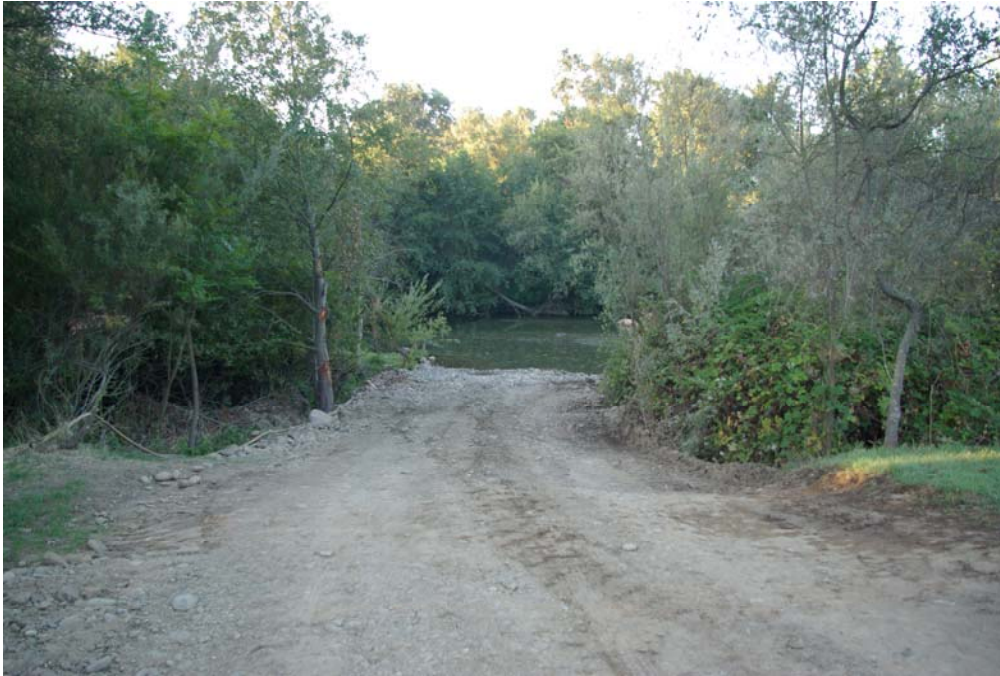
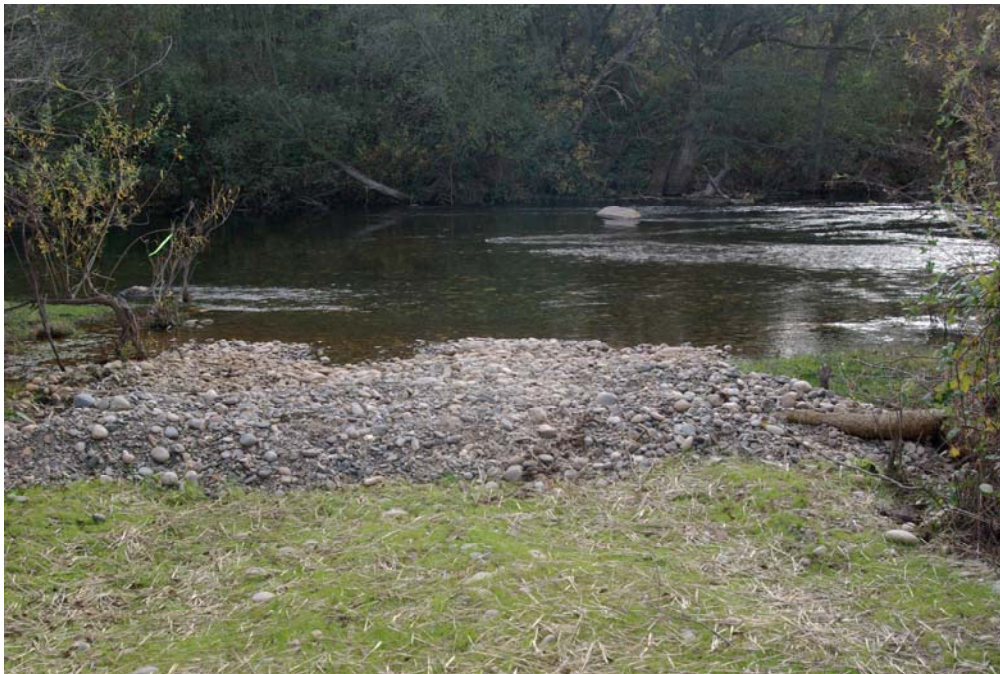
Figure B-5. River access road pre (a) and post (b) erosion control measures. A nine foot straw waddle was placed and covered in spawning gravel at each of the access points.

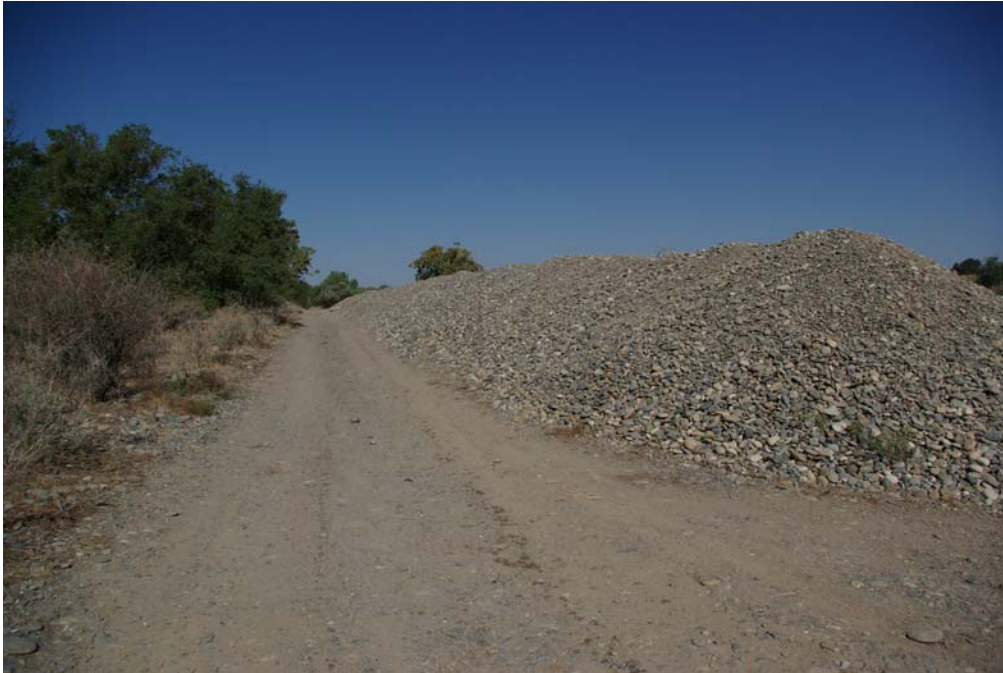
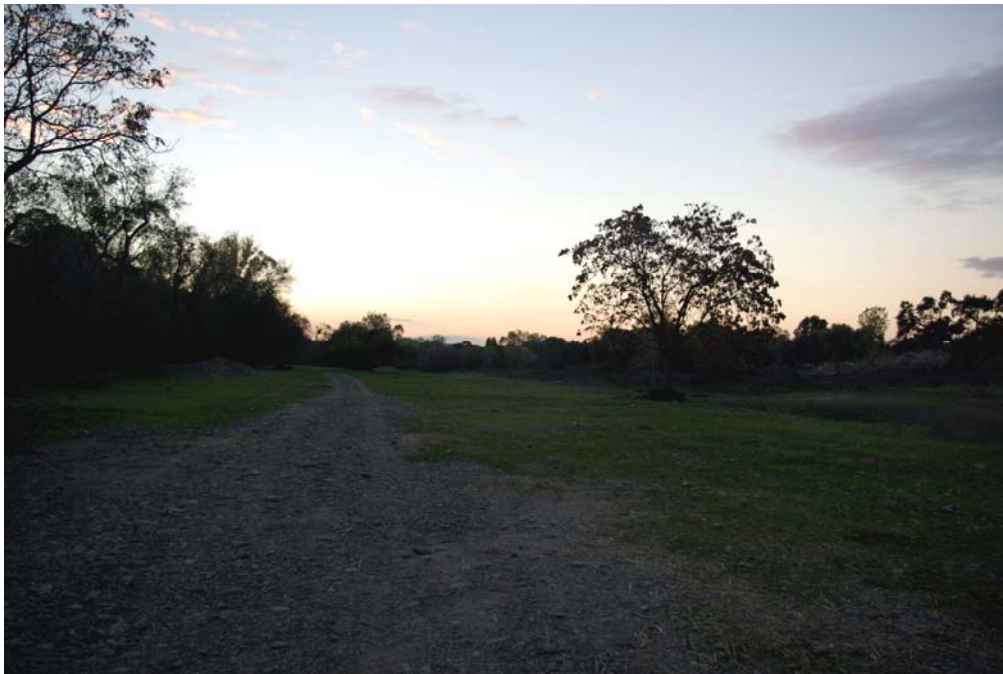
Figure B-6. Gravel stockpile area before (a) and after (b) erosion control measures.

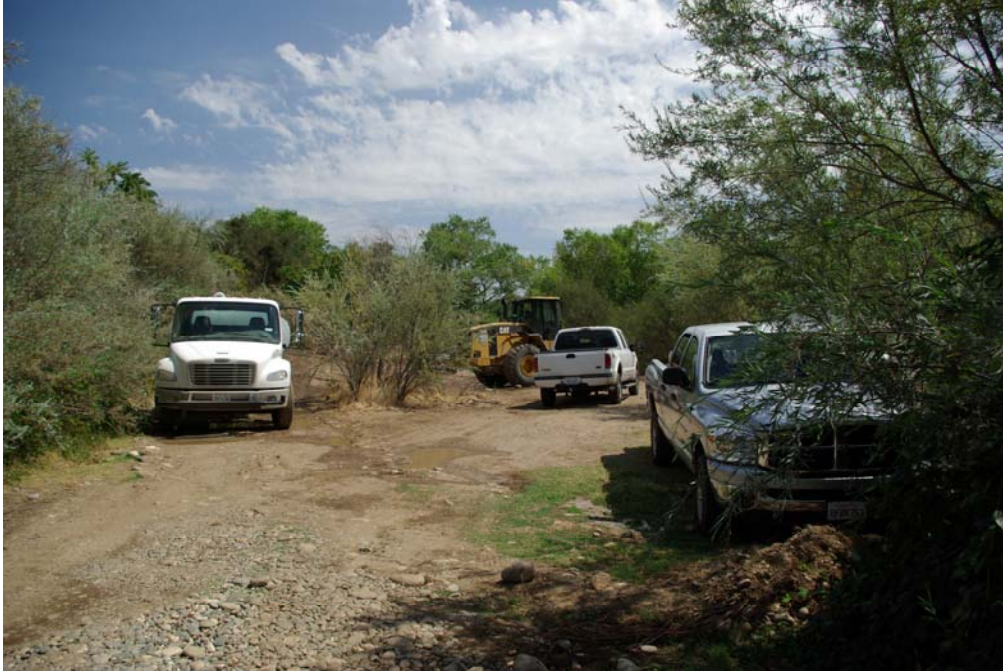
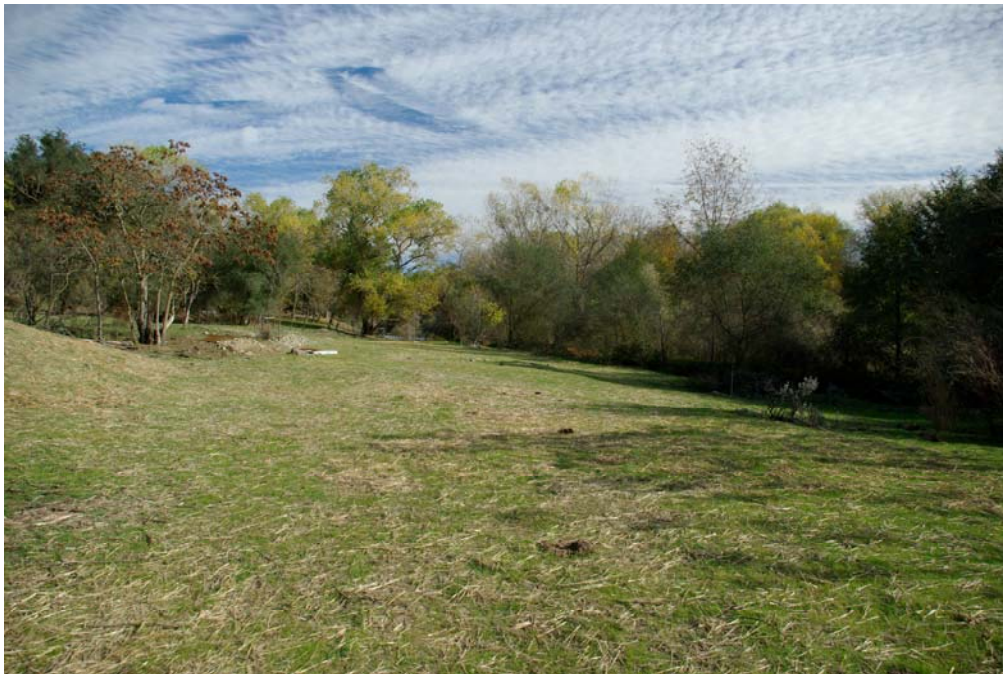
Figure B-7. Restoration staging area pre (a) and post (b) erosion control measures.
